Manhole Inspection Summary

Manhole # S43CC_048MH

Insp Date: **1/8/08 10:16 AM**

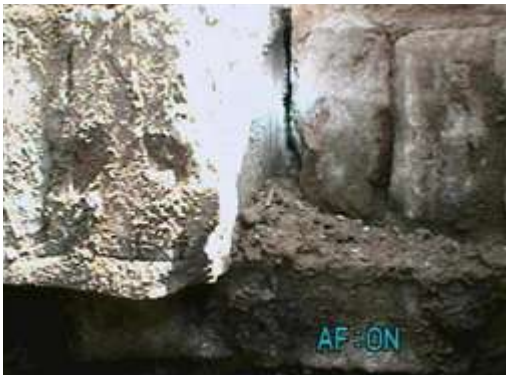
Defect 1

Condition: ☐ Sound ☐ Cracked ☐ Root Intrusion ☒ **Loose Brick** ☒ **Deteriorated**

chimney cond loose bricks, chimney cond deteriorated

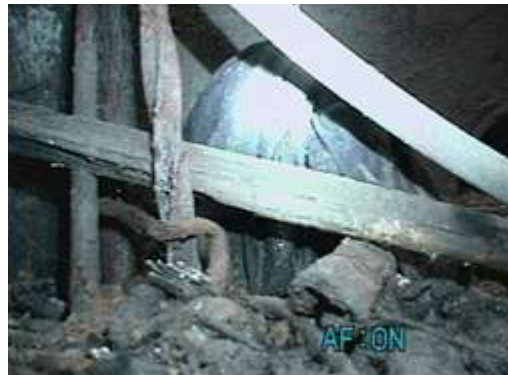
Defect 4

Condition: ☐ Sound ☐ Cracked ☐ Root Intrusion ☐ Deteriorated ☐ Leaks ☒ **Debris**

channel debris

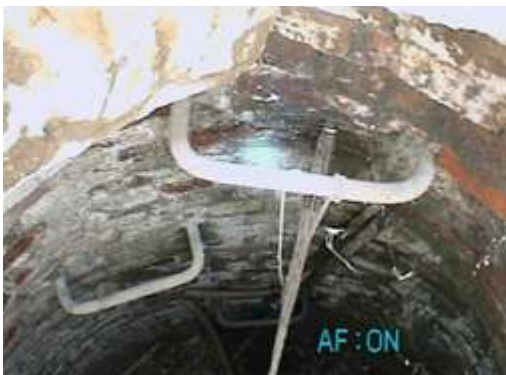
Defect 3

Steps Count: **3** Missing: **0** ☒ **Corroded**

steps

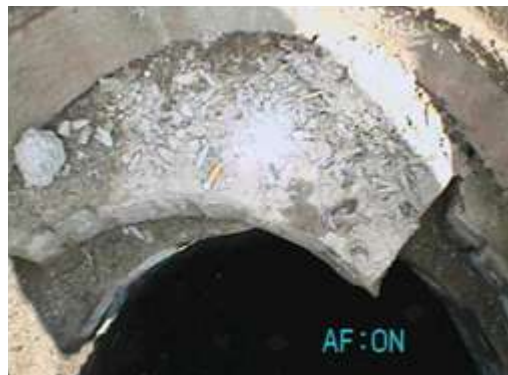
Defect 2

Frame Offset: **10** (in.) Condition: ☒ Sound ☐ Cracked ☐ Leaks

offset

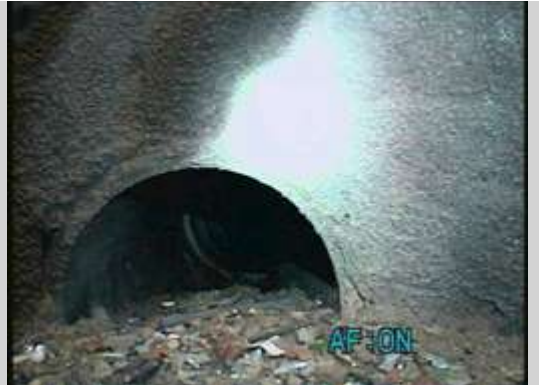
12 O'Clock Outflow

8 in. Circular Gravity Sewer
Pipe Out @ 12 O'Clock

Deposits: ☐ None ☐ Mud ☐ Sludge ☒ **Debris** ☐ Grease

Silt Depth: 3 (in.) Deposits Extent: **Medium**
